## DEVELOPMENT OF A HIGH TEMPERATURE SILICONE BASE FIRE-RESISTANT FLUID FOR APPLICATION IN FUTURE MILITARY AIRCRAFT HYDRAULIC SYSTEM DESIGNS

J. Lee Hammond and Alfeo A. Conte, Jr.  
Air Vehicle Technology Department  
NAVAL AIR DEVELOPMENT CENTER  
Warminster, Pennsylvania 18974

15 JUNE 1977

PROGRESS REPORT  
TASK AREA NO. WF41-451-208  
Work Unit No. ZA101

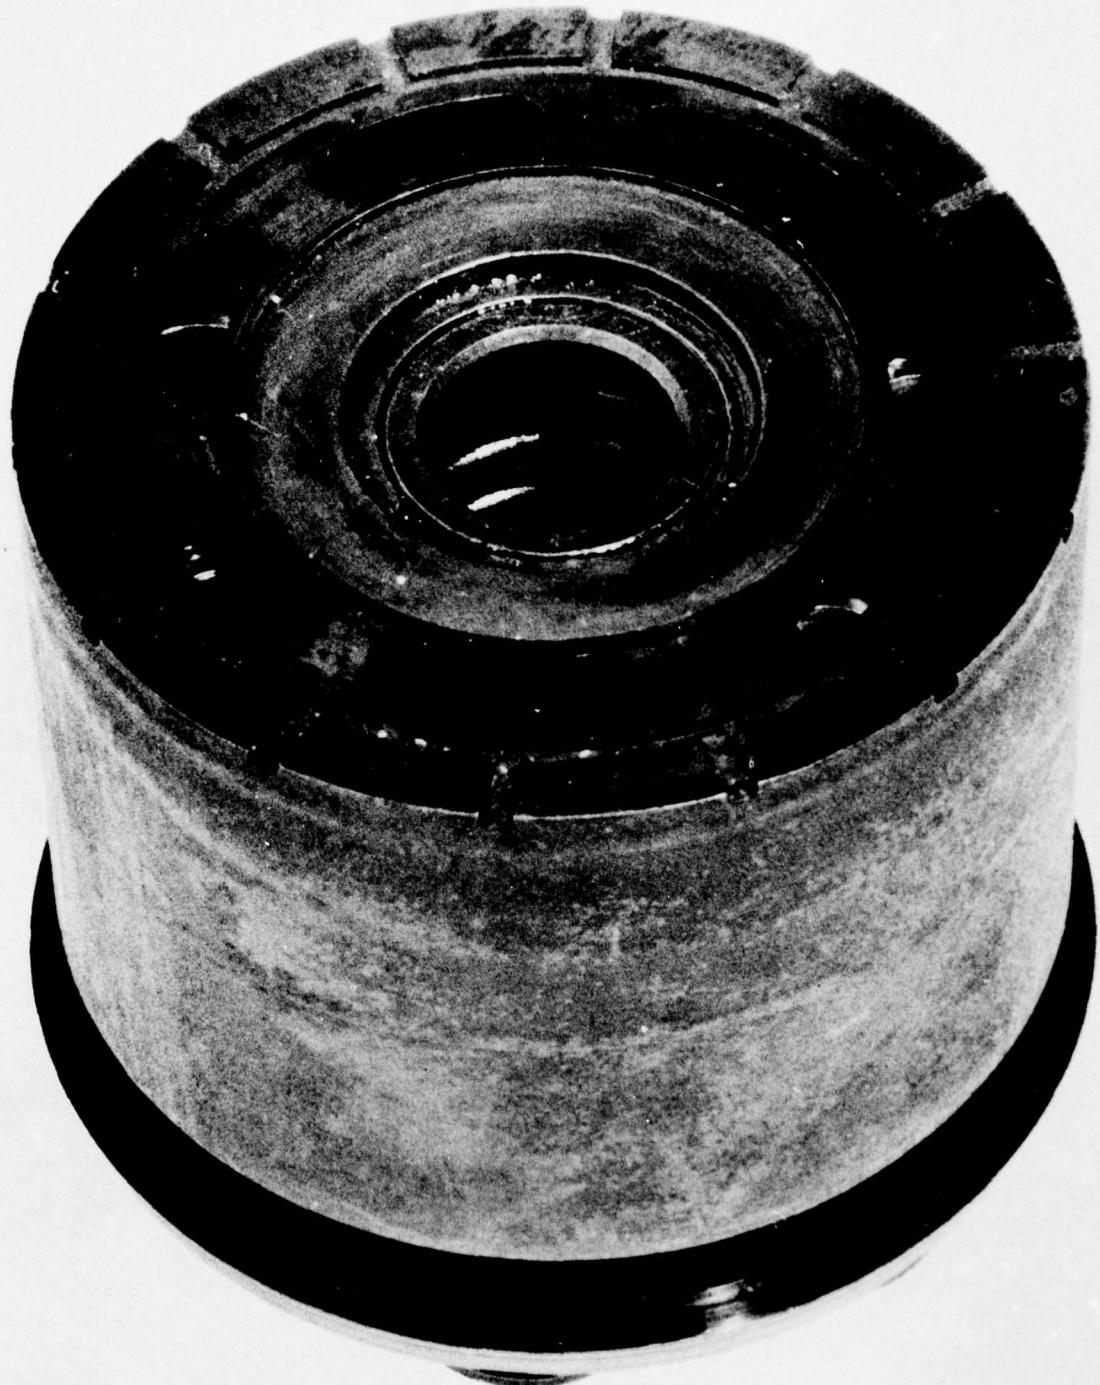
FIGURE 15 - Cylinder Block After Test

After 500 hours of performance, the pump was disassembled, photographed and dimensions and weights taken on critical friction elements. Table XI summarizes the dimensional and weight changes obtained where they could be measured. Minimal changes were observed on all components with the exception of the cylinder block which increased in weight by 8.3 grams. Figures 5 through 14 show the condition of the pump components before the test while Figures 15 through 21 show most of the same components after the test. The piston shoes shown in Figure 8 had many score lines on each assembly before the test. The other components were found to be in excellent condition. In general, after the test, many of the components had a coating or deposits on them. The exact nature and origin of these deposits is not known. The deposit on the pump housing (Figure 17) could be easily wiped off while the coating on the other components had to be mechanically abraded.
